GENRE : A M A

MODEL : **TS-2000/X, TS-B2000**

SUBJECT : **Modulation output delays about 2 seconds toward PKD input signal**

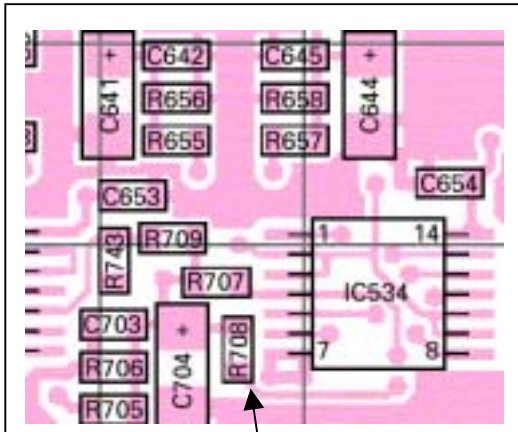
When TX is done with using ACC2 PKS terminal, modulation output delays about 2 seconds toward PKD input signal.

C A U S E : Firmware problem

1. Take off the resistor **R708**
2. Attach the resistor **RD14BB2C473J** between C701 and C705.

X53-391 Control unit / Component side view
Take off the R708
