## Some technical and maintenance issues regarding the IC-781 and IC-R9000

*by Traian Belinas, YO9FZS*

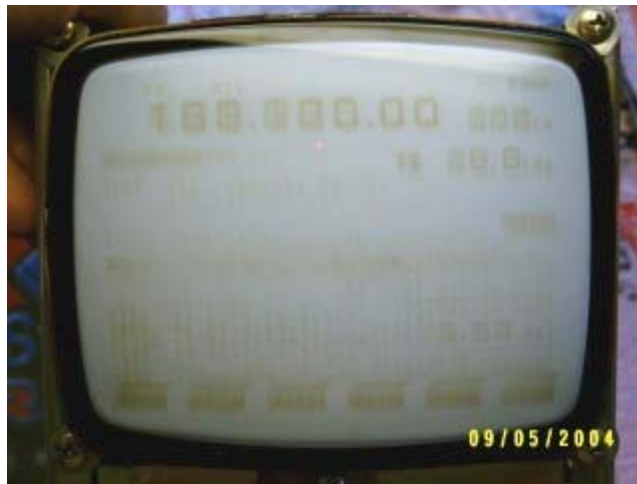
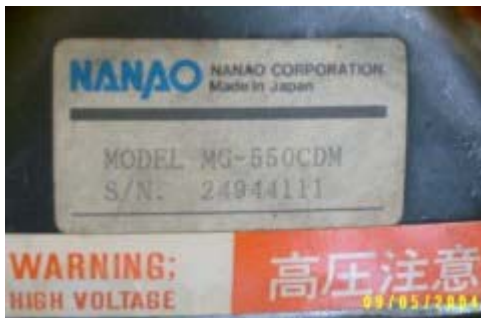
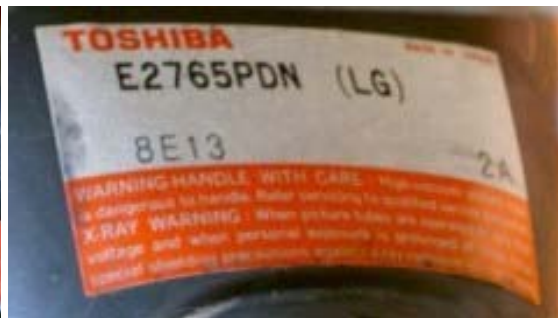
It is as if the picture pattern has been "imprinted" on the CRT screen. For the affected areas, the picture brightness and CRT phosphor efficiency is lower.

**This is permanent damage and cannot be corrected or avoided, but fortunately this kind of problem is not really catastrophic – this type of CRT may still function for many years after the first visible appearance of the burns, even if it may be uncomfortable to some. If needed, an external video monitor accepting NTSC CVBS input may be also used (or NTSC TV).**

You may see below how these burns may look; this example is from an IC-R9000.

The CRT below had maybe 10 years of use, most at a government agency before I got it (so it may had intensive use), and even now after I have sold it, it is still functioning at the new owner's QTH without these burns causing much trouble. This is also because the CRT itself is a relatively good quality one made by Toshiba. The CRT module is made by Nanao.

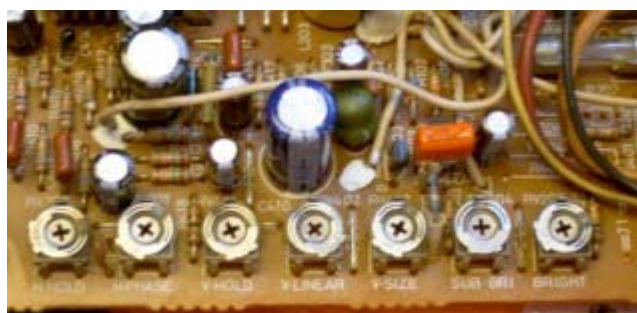
The low brightness of the old used CRT’s may be improved by using the internal adjustments of the CRT module. You have to open the CRT module top cover to gain access to them. To do this, you need to open the transceiver case, then to take out the six screws holding the CRT module top cover. The ATU preset pots PCB must also be removed. These adjustments are located on the CRT module PCB, close to its right side:

**SUB-BRI and BRIGHT** are the ones adjusting the brightness of the picture; adjusting them CW will increase the brightness of the CRT displayed picture.

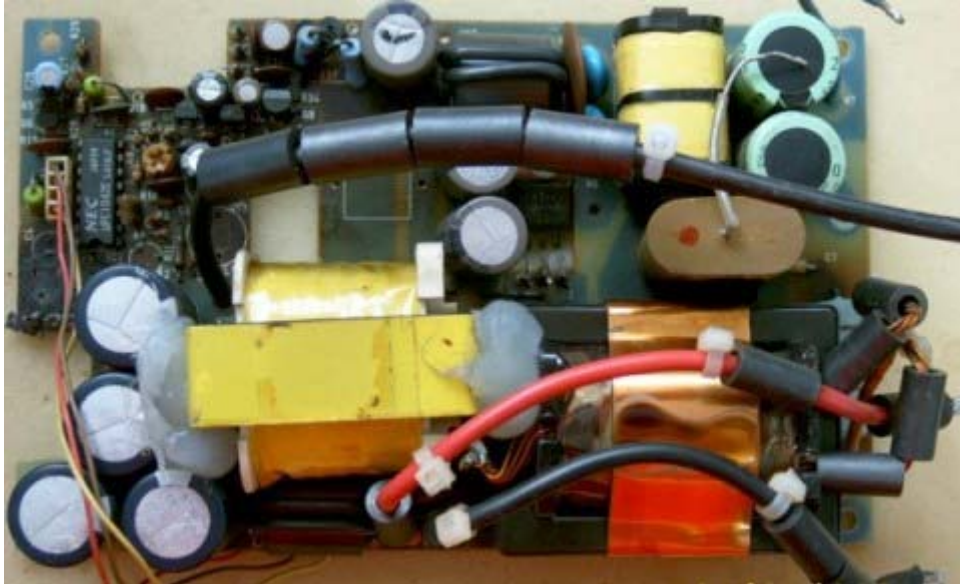
This is why overheating may damage the REG PCB, and the PCB itself may present burned areas and/or burned PCB traces, especially in the area close to R32 and Q7. Power resistor R32 can dissipate its rated power at 25°C, but not at 70°C... This overheating may also affect the electrolytic capacitors and even other small parts close to them. Special attention needs to be paid to potentiometer R2, which is included in the switching supply feedback loop. If R2 goes open or is damaged, it may cause output overvoltage, with possibly harmful consequences.

The REG PCB with most of the original parts on it;  
A few of the overheated parts near R32 area were already removed.

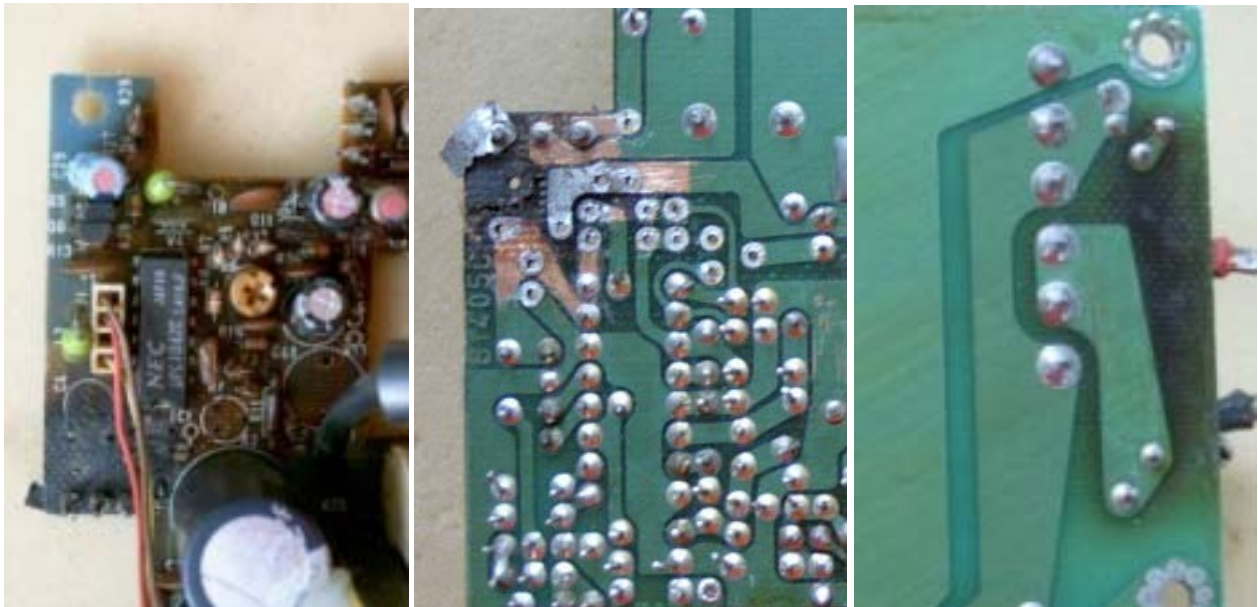
Burned PCB and copper traces near the R32, Q7 and R26; some parts are missing here.

Don't hesitate to make use of better and more trustworthy spare parts, it is not necessary to look for the 20-year-old “authentic originals”. I have found Q7 shorted and R32 interrupted and overheated. The 2SD1406 used for Q7 has 20W dissipation and maximum collector current 3A. I have used a 70W 8A TIP132 Darlington and insulating mica foil instead of the 2SD1906. [Don't use much higher current/power bipolar transistors as they usually have very low amplification (beta) and D5 may not withstand the higher base current required]. Don't forget to use thermal compound, insulating washers and mica foil where needed (D2, D3, Q2, Q3). Before assembling the PCB you may check the uPC1042 IC (it has to start oscillating) and verify the +9V and +5V regulator functionality after connecting an external current-limited 15V PS at C13 (observe polarity). Re-install the PCB inside its compartment only if all of these are OK. As a precaution, you may insert a 3.15A fuse in the 280V line (you may also leave it in circuit).

- Restore the PCB's circuit connections as needed, using the terminals of the newly installed parts if required;
- Check and if needed replace Q7, R32, D5, R2;
- Replace the small electrolytics with new high-quality parts; these must be rated for 105°C;
- If any sign of damage is visible at the C8, C9, C13, C15, C16, C20 to C23 (electrolytics), these may be replaced if spares are available - use the highest quality parts obtainable. Remember that the power supply must deliver 500W DC output and the caps must also be of 105°C type.

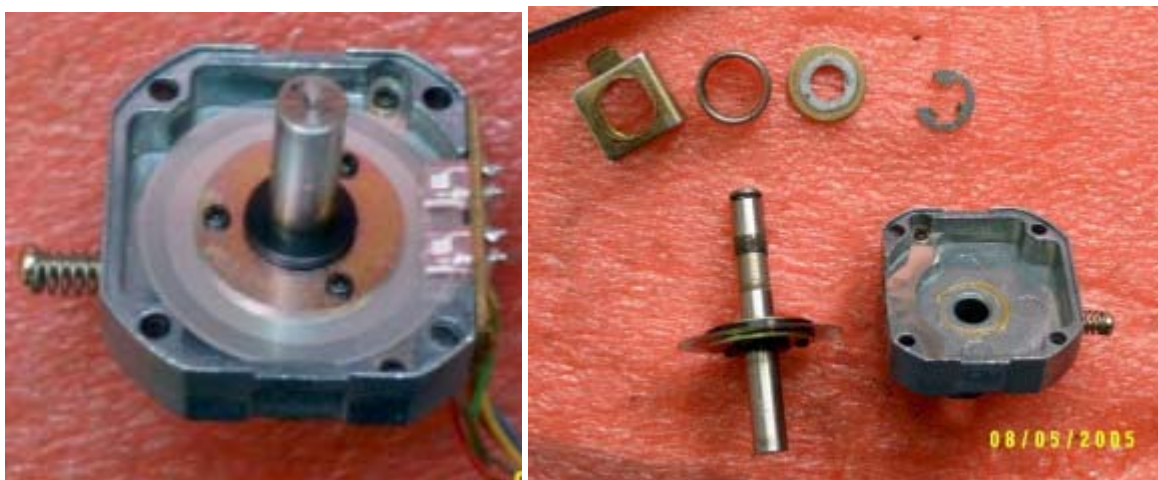
For both radios the VFO encoder knob had been rotating with some difficulty, even when its adjustable brake was released. This was caused by the old grease used in the shaft bearing. This grease has solidified because of age. It is inadvisable to use the radio with a stiff encoder shaft for any length of time, as this will cause a rapidly increasing backlash.

Clean the dirty shaft and the sleeve bearing remove the existing grease using isopropyl alcohol and then re-lubricate shaft and bearing. To reduce any backlash, lubricate with grease rather than oil. Don't use much grease; a small quantity will suffice. Avoid getting lubricant on the optical parts;

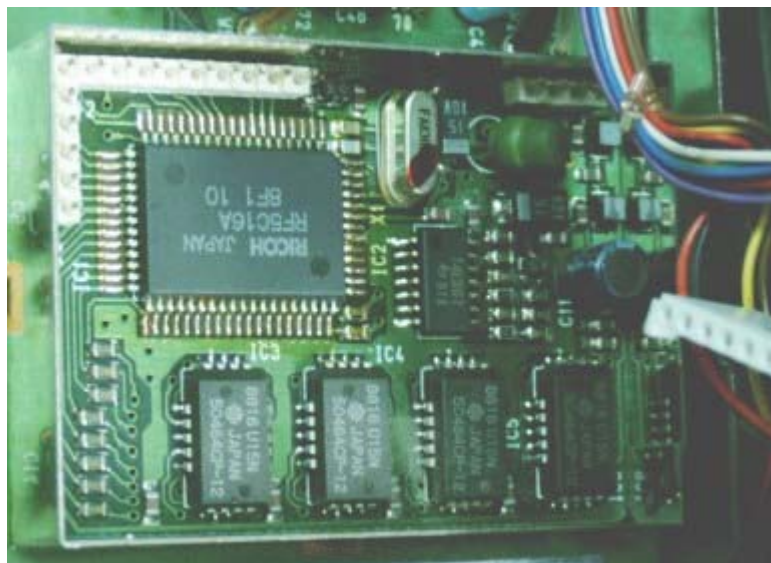
The opened CRTC module;  
C11 is the blue cap, to the right of the CRTC module.

As the CRTC module is hard to remove from the Digital board, I had to cut/extract the body of C11 while leaving its terminals still attached to the PCB. Then carefully free its terminals from the PCB by heating them with a soldering iron from the component side. I have used a small 100uF cap (a slightly larger value one will do also) which was installed horizontally over the passive components near IC2, with its terminals bent down and soldered at the original C11 holes from the more accessible component side of the PCB. This avoided the need for removing the entire CRTC module, a difficult and time-consuming exercise. Don't forget - use a good quality capacitor and you may not have any further problems in this area.

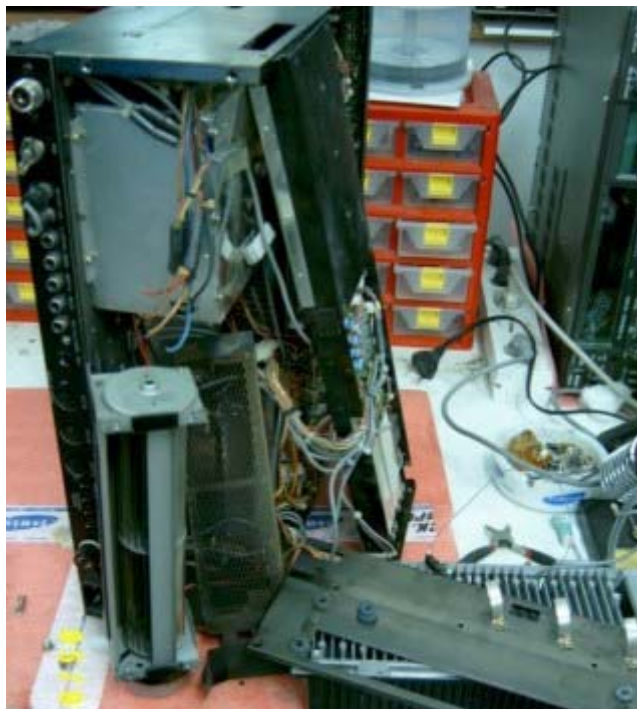
IC-781; heatsink and fan removed;

The fan is sitting on its motor side, and the sleeve bearing is at the top part of the fan's case

It is located under the RF/Filter Units module at the rear left side of the radio, and is attached to the big heatsink with screws. This fan may need lubrication. Its motor may have ball bearings (not requiring lubrication) - but the other end of the squirrel cage, at the right side looking from the front, it uses a sleeve bearing. The RF/Filter module has to be removed to gain access to the fan. Putting the radio on its left side may help to apply a small drop of oil to the sleeve bearing using a syringe.
