Service Information

To : ICOM Distributors
 From : ICOM Inc. / CS Department
 Ref No. : ZSM00010
 Date : March 14, 2006

IC-7000 : Stop the AF 8 kHz Tone Noise

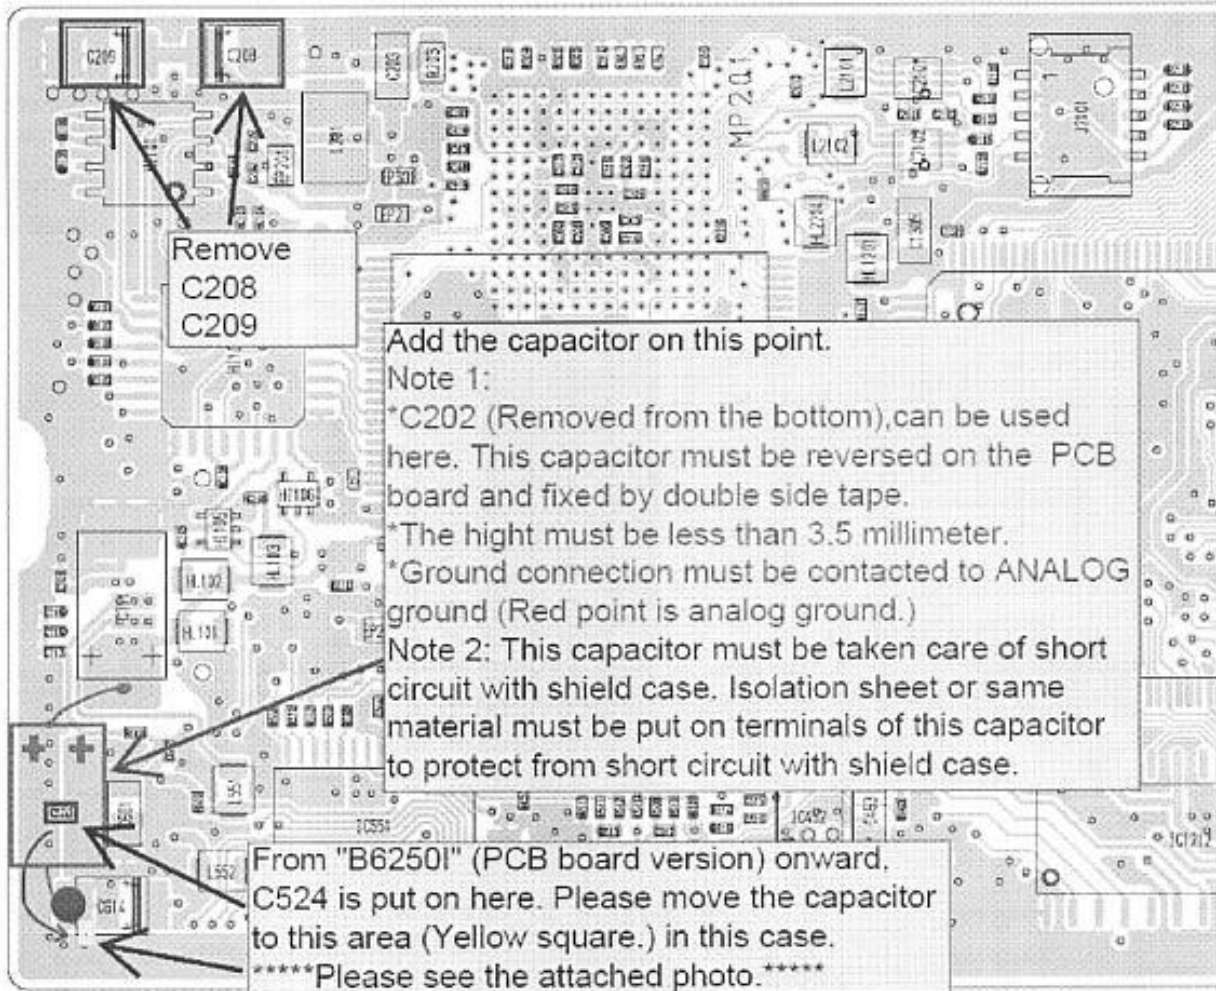
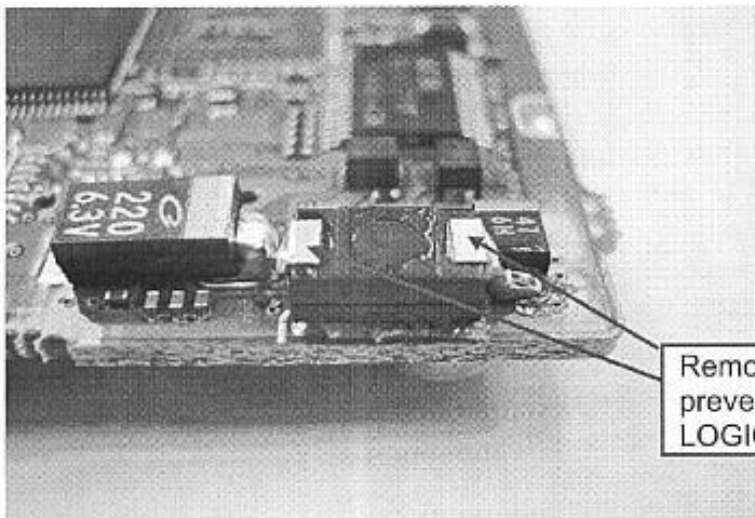
<IC-7000 LOGIC UNIT : TOP VIEW>

Some IC-7000 transceivers may have the symptom of 8 kHz Tone Noise in AF. This noise appears when hearing AF with headphone. From Rear EXT SP jack, stronger noise appears compared to FRONT PHONE/SPEAKER jack. The following is how to stop this noise.

1. Model IC-7000
2. How to improve Change the location of capacitors
3. Replace parts Remove capacitors from LOGIC UNIT

Ref. NO.	Part NO.
C207	4030018960 C3216 JB 1C 106MT-N
C208	4550006780 TEESVB2 0J 476M8R
C209	4550006780 TEESVB2 0J 476M8R
C202	4550007310 F930 J227MNMBMA
(Replace)	Replace C202 form the bottom → top of the LOGIC UNIT
