16 March 2010

***UPDATE* TO THE IC-7000 DRIVER UNIT FAILURE PROBLEM**

By sv8ym

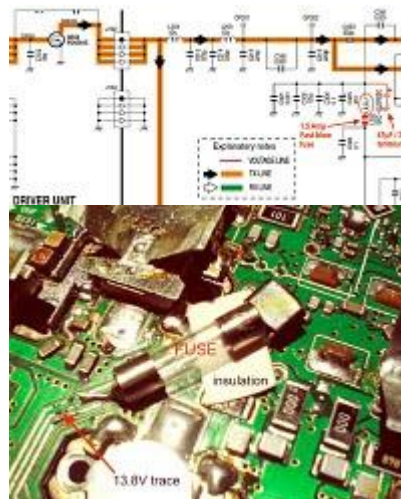
3) Addition of a driver unit protection fuse

IF YOU DON'T WANT TO LIFT THE PA UNIT PCB, USE THE ALTERNATIVE METHOD DESCRIBED IN THE PINK DIAGRAM BELOW!

Adding a fuse to the 13.8V DC line feeding the driver transistor's drain improves the chances that even if instability occurs, the transistor will survive. (There won't be the usual fireworks and smoke, in any case!) Having lifted the PA UNIT, locate **L302** on the PA UNIT (see the schematic diagram on this page and the next pages for diagrams and photos). Unsolder it and transfer it to the "bottom view" (the one you see after removing the rig's cover) of the PA UNIT (as shown in the service manual), soldering only the lead that connects it to the node with **C305** and **L301**. Then solder an 1.5 A, fast-blow 20mm glass fuse (or equivalent) to the free lead of L302 in the way shown in the photo, soldering the other end of the fuse to the PCB trace that L302 used to connect to (it's the "b" line with 13.8V on it). Use a small piece of wire to solder the fuse to the trace. **Don't locate the fuse elsewhere using long wires! Do it exactly as shown.** Lay the fuse flat on the PCB. Use a small piece of thick paper or plastic sheet to insulate the end of the fuse soldered to the free lead of L302 from the PCB trace under it. After you have finished, cover the fuse with a piece of electric tape to prevent shorting the 13.8V line when replacing
