Bob Lanning – W6OPO February 8, 2008

In October 2007 I bought and installed INRAD's just announced roofing filter for the IC-781. The filter works fine as a roofing filter but I did not like how it modified the radio's spectrum scope display. The filter significantly attenuated the amplitude of the displayed signals appearing beyond +/-5kHz each side of the center frequency. With the filter located *after* the scope pick-off point I would not expect this kind of response but there it was. After some investigation and testing I found a way to correct what I considered an unacceptable condition.

Alternative IC-781 INRAD roofing filter installation

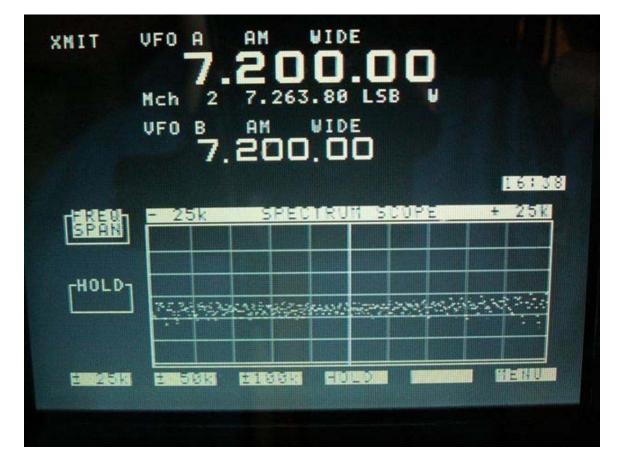
Original IC-781 Spectrum Scope display with no roofing filter:

The first picture is without a filter showing essentially uniform amplitude of the HP8640B's FM signal. The second image is with the filter installed per INRAD's recommendation. Here you can see the attenuation of signals beginning 5kHz either side of the center frequency. The third image is the result when it was moved to the output of Q8 the buffer amplifier.

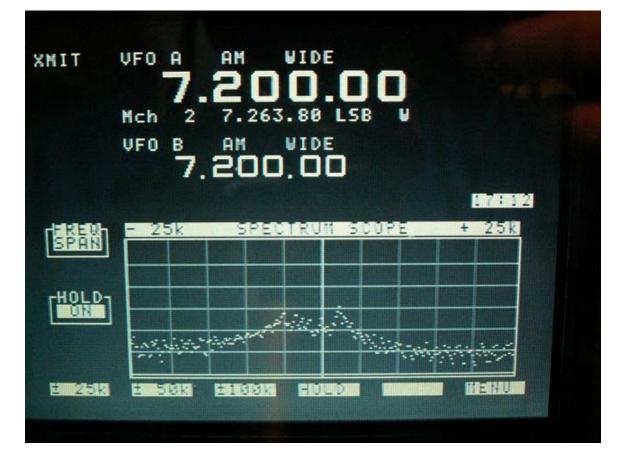
Spectrum Scope response with roofing filter in Inrad's position:
