GENRE : A M A

MODEL : **TS-2000/X, TS-B2000**

SUBJECT : **Modulation output delays about 2 seconds toward PKD input signal**

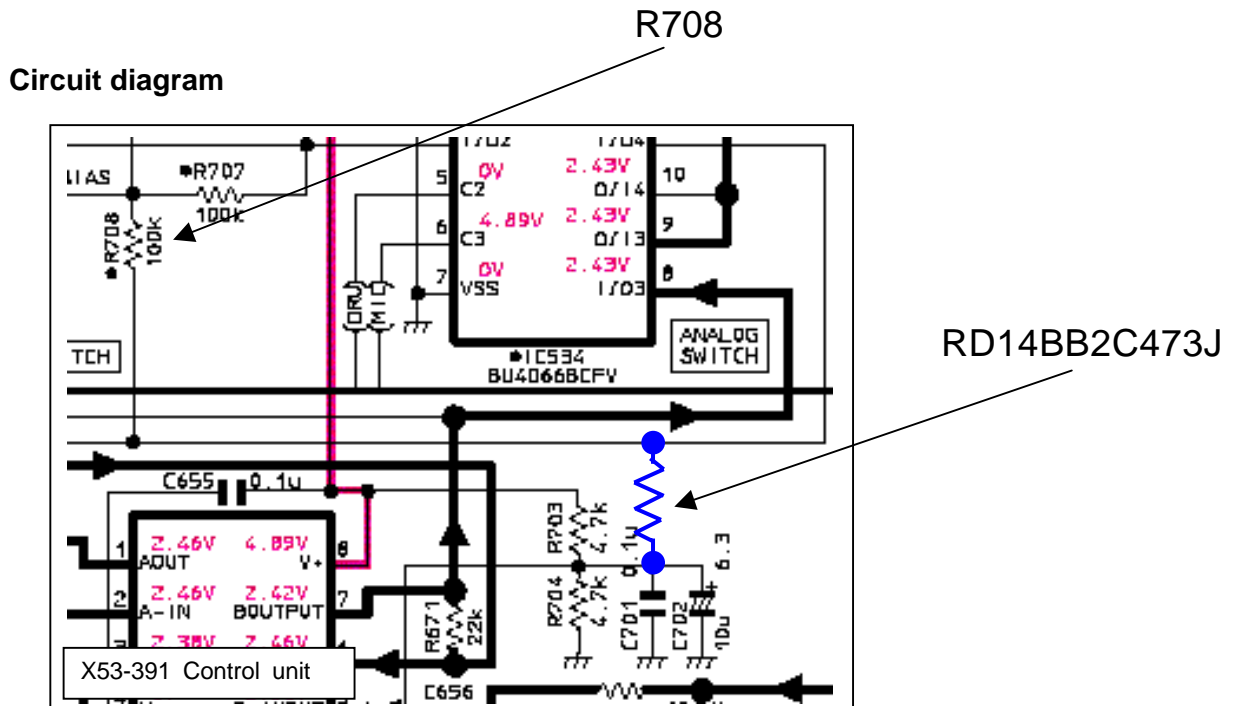
When TX is done with using ACC2 PKS terminal, modulation output delays about 2 seconds toward PKD input signal.

C A U S E : Firmware problem

4. Update the main CPU firmware to **TS2000_MAIN_KE_SH01_REL08_8BD6.mot** with writing software W05-0855-00 (FWS for 2000).

note : After modifications, there is no necessity of adjustment.
