## Some technical and maintenance issues regarding the IC-781 and IC-R9000

*by Traian Belinas, YO9FZS*

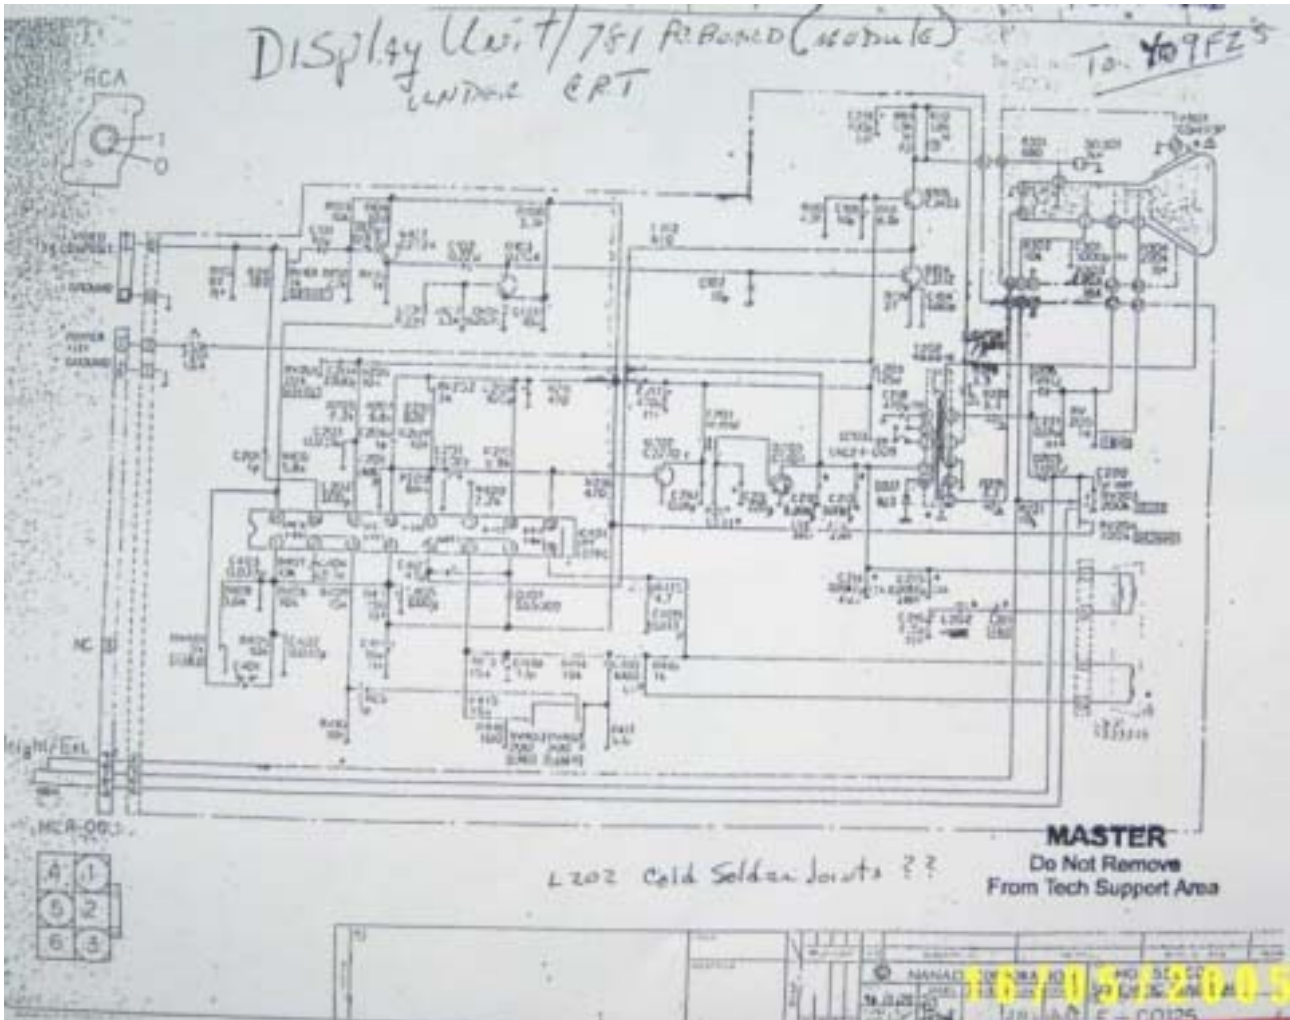
The CRT module diagram is not included in the service manual, but the above is a low-resolution copy which may be of some help (many thanks to K2SB).
