16 March 2010

***UPDATE* TO THE IC-7000 DRIVER UNIT FAILURE PROBLEM**

By sv8ym

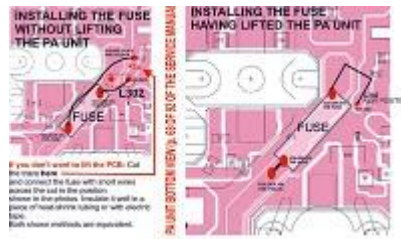
(Note: Originally, I thought about installing a current limiting circuit using two NPN transistors and some resistors in the DC line to the driver stage, instead of a fuse. This circuit would conceivably prevent a catastrophic secondary-breakdown scenario. Due to the severe lack of space and the relative complexity of this solution, I opted for the fuse. Anyway, I think this idea has merit, in the future I may try it.)

Adding a fuse to the 13.8V DC line feeding the driver transistor's drain improves the chances that even if instability occurs, the transistor will survive. (There won't be the usual fireworks and smoke, in any case!) Having lifted the PA UNIT, locate **L302** on the PA UNIT (see the schematic diagram on this page and the next pages for diagrams and photos). Unsolder it and transfer it to the "bottom view" (the one you see after removing the rig's cover) of the PA UNIT (as shown in the service manual), soldering only the lead that connects it to the node with **C305** and **L301**. Then solder an 1.5 A, fast-blow 20mm glass fuse (or equivalent) to the free lead of L302 in the way shown in the photo, soldering the other end of the fuse to the PCB trace that L302 used to connect to (it's the "b" line with 13.8V on it). Use a small piece of wire to solder the fuse to the trace. **Don't locate the fuse elsewhere using long wires! Do it exactly as shown.** Lay the fuse flat on the PCB. Use a small piece of thick paper or plastic sheet to insulate the end of the fuse soldered to the free lead of L302 from the PCB trace under it. After you have finished, cover the fuse with a piece of electric tape to prevent shorting the 13.8V line when replacing
